Manhole Inspection Summary

Manhole # S29MM1003MH

Insp Date: **10/14/08 12:20 PM**

Location Address: **LINKWOOD RD**

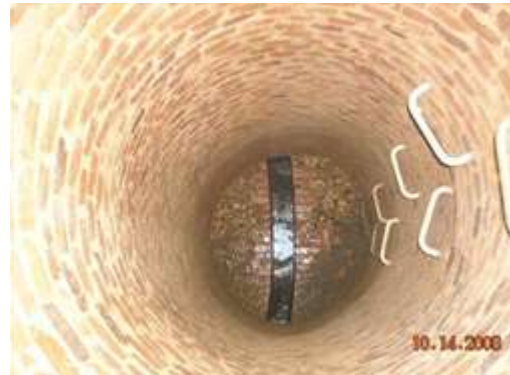
Top View

Evidence of surcharge - Bench debris.
Channel debris.

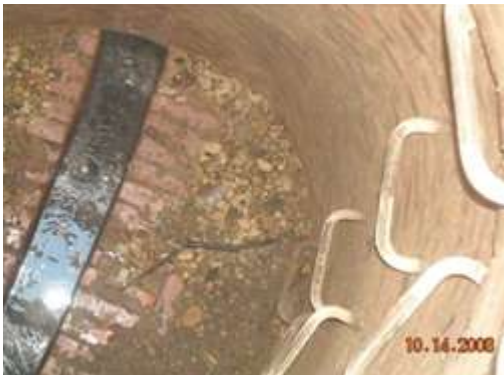
Defect

Barrel infiltration.

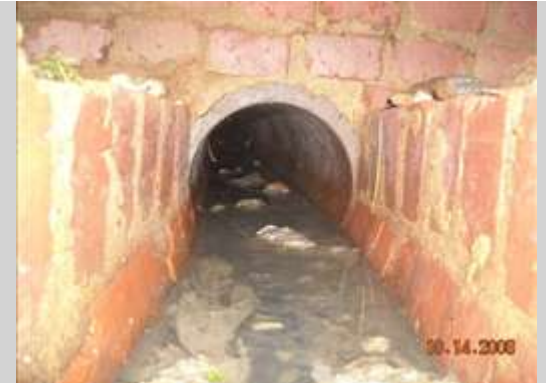
8 in. Circular Gravity Sewer Pipe Out @ 12 O'Clock

Deposits: ☐ None ☒ **Mud** ☐ Sludge ☒ **Debris** ☐ Grease

Silt Depth: **1** (in.) Deposits Extent: **Light**
